Report Index Page

March 8, 2009

Ryan Smith
214 John Matthew Street,
Halifax, Nova Scotia,
B3K 2M2.

ARMOUR HOME INSPECTION

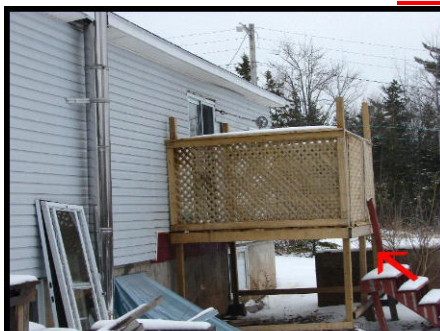
- Stairs are not proper and pose a serious safety concern especially for fire escape purposes. Proper stairs are required to be installed.
- Deck is not supported properly. Old tires and cement post blocks are used in this install and do not provide proper support for deck structure.
- Deck is nailed to structure and should be lag bolted to solid structure. Decks nailed to house structure tend to pull away from the home over time or during heavy loads and pose a safety and liability risk.

Back Deck. Major issues

This deck will require major repairs and a qualified licensed carpenter should be called in to evaluate and quote on repairs.

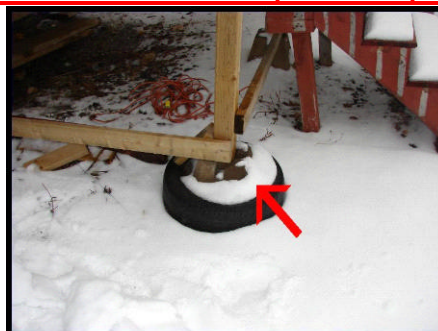
Deck is not supported property. Old tires and cement post blocks are used in this install and do not provide proper support for deck structure.

Improper support for deck

This deck will require major repairs and a qualified licensed carpenter should evaluate and quote on repairs.

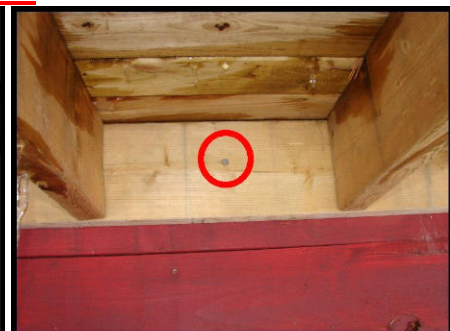
Deck is nailed to structure and should be bolted to solid structure. Decks nailed to house structure tend to pull away from the home over time or during heavy loads and pose a safety and liability concern.

Deck nailed to structure.

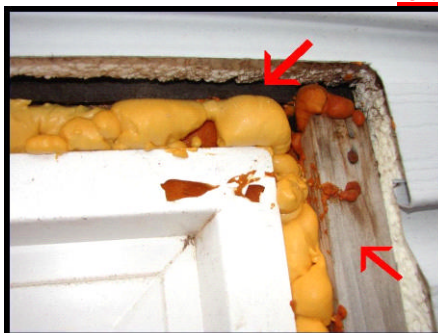
3.2 CONDITION: Needs major repairs. The siding on the exterior is in very poor condition and there is a concern water may leak into the home through the gaps and window areas because they are not sealed water tight. .
Multiple areas of siding were loose, not fastened properly or the siding was cut too short leaving large gaps for water to enter. .

Siding and trim not finished

The siding will need to be re-installed on this home by a Professional siding installer to make the home water tight. .

The wall sheathing behind the siding should be checked by the professional for moisture damage and mould in the areas that were not protected with siding and left open to the elements.

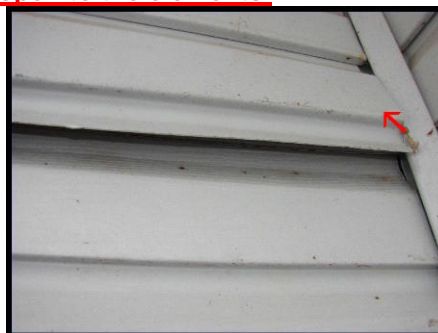
Multiple areas of siding were loose, not fastened properly or the siding was cut too short leaving large gaps for water to enter.

Siding not secured to structure

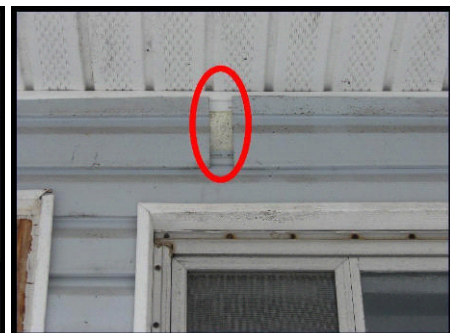
Multiple gaps noted in siding

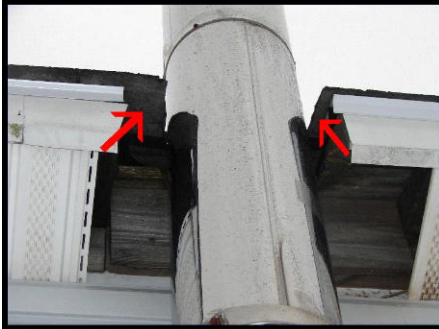
3.4 CONDITION: The roofing material is too close to the chimney. A 2" clearance to all combustible material is required for this particular manufacture of chimney as stated on the warning label affixed to this chimney.

Stainless Steel Wood stove chimney

The material surrounding the chimney will need to be cut back to give the chimney the 2" clearance required.

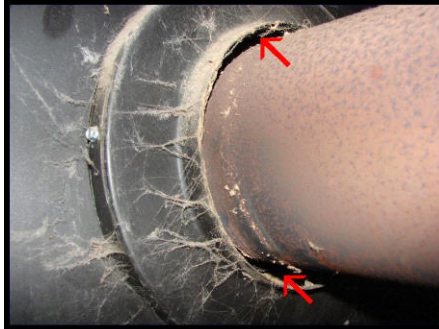
The flue pipe leading from the stove to the base of the stainless steel chimney is not installed properly and poses a major health risk to the home occupants. Fumes and gases from the wood stove could spill into the basement area of the home through these large opening around the flue pipe. .

Flue Pipe - Poor seal to chimney

A WETT certified technician should be called in to make proper repairs to the flue pipe to properly secure it to the stainless steel chimney and provide a proper seal to expel the fumes and gases from the wood burning stove safely. .
